# CONCRETE BRIDGE DETAILS

PORTLAND CEMENT ASSOCIATION

First Edition 1935

# A discussion of structural details

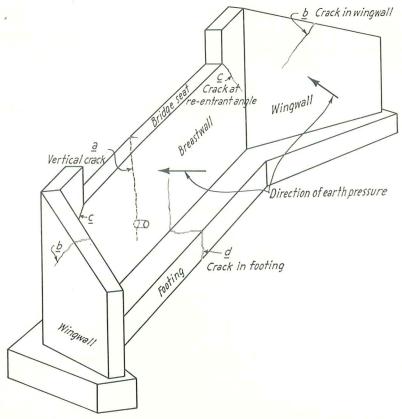
FIG. 3 Typical cracks that may develop in the common abutment type when the conventional analytical methods take little or no account of the actual behavior of the abutment.

The cantilever retaining wall, probably the type most commonly used for breastwalls, sometimes develops cracks similar to a in Fig. 3. Such cracks may be prevented as will be seen after a brief discussion of their contributing causes, among which are: (a) non-uniform shrinkage, (b) a discrepancy between design assumptions and actual behavior, and (c) the earth pressure on wingwalls. The relative effects of these phenomena are uncertain, but all of them act to create tension in the front face of the breastwall.

Using the first method, wingwall cracks of type b in Fig. 3 may be eliminated by adding sufficient reinforcement as indicated by bars marked b in Fig. 4.

Bars in Front Face 'According to this discussion, an abutment of the type shown in Fig. 3 can be improved by adding horizontal bars near the front face. Bars a in Fig. 4 provide for both horizontal beam action and shrinkage, and are recommended for use with the regular reinforcement provided for cantilever action. In addition, it is sometimes advisable to place vertical bars near the front face. These bars will take the tensile stresses developed in case the breastwall acts as a vertical beam supported horizontally by the deck and by the foundation, a loading condition that will be discussed in the section on Abutment Movements.

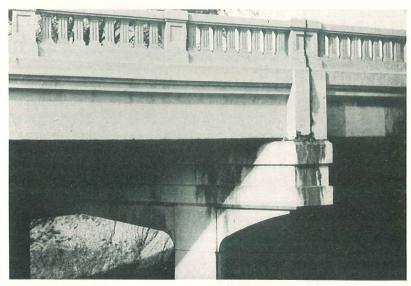
# FIG. 26

Importance of Preventing Seepage Seepage is commonly observed and water stains often mar the beauty of bridges, as illustrated in Fig. 26. Moreover, failure to

FIG. 26 Seepage through deck joint has caused unsightly water stains and may damage the pier cap. This illustrates the need for proper joint details.

prevent seepage through joints and cracks is responsible for a good deal of local damage in otherwise durable structures.

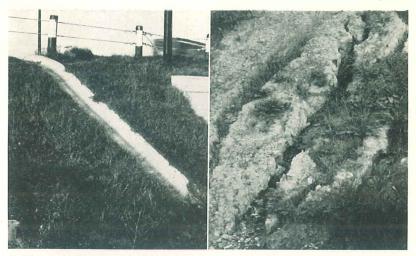
# FIGS. 36 and 37

FIGS. 36-37 Concrete gutter and sodding protect embankment slopes against erosion. Eroded slopes detract from the appearance of bridge structures.

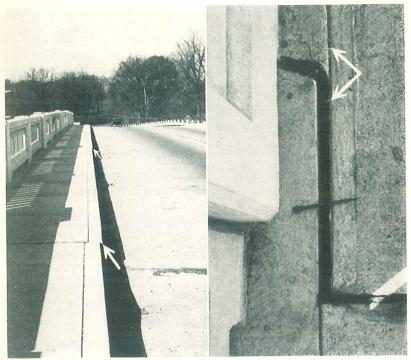
## FIGS. 48 and 49

In some instances, the evidence reveals creep at the expansion bearing of the deck. For illustration, the multi-span bridge shown in Figs. 48 and 49 has one expansion and one fixed bearing on each pier. The offsets in the curb line illustrated in Fig. 48 show a creep of about 1¼ inch in each expansion bearing. This creep can also be observed in Fig. 49, which shows a close-up of part of the joint in the sidewalk on the same bridge.

FIGS. 48-49 Skew multi-span bridge exhibiting creep at expansion supports. Note offset of about 1½ inch in curb at each pier (left) and increase in width of joint in sidewalk (right) both caused by creep.
